EXPANDED
SCREENING SITE INSPECTION REPORT

TREASURE ISLAND-MANHATTAN DUMP
2020 Manhattan Boulevard
Toledo, Ohio 43612

U.S. EPA ID NO.: OHD 980 611 305

EPA Work Assignment No.	:	29-5JZZ
EPA Region	:	5
Date Prepared	:	September 14, 1993
Contract No.	:	68-W8-0084
PRC No.	:	030-002968
Prepared by	:	PRC Environmental Management, Inc. (Kristine Kruk)
Contractor Project Manager	:	Julie Kaiser
Telephone No.	:	(312) 856-8700
EPA Work Assignment Manager	:	Jeanne Griffin
Telephone No.	:	(312) 886-3007

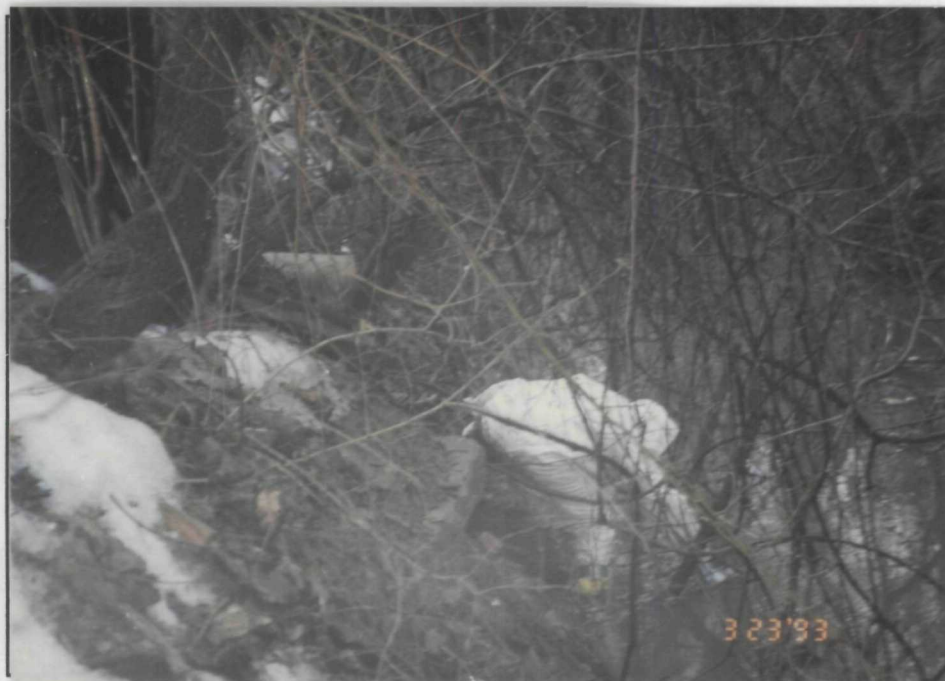
Sample No. SW-02 was collected along the southern bank of the storm sewer drainage ditch about 200 feet downgradient of Sample No. SW-01 (see Photograph No. 1). Sample No. SW-02D was collected as a duplicate for Sample No. SW-02. Sample No. SW-03 was collected on the western bank of the northeastern pond. An OEPA on-site investigation states that leachate was observed seeping in the pond in this area. Sample No. SW-04 was collected from a potential wetland on the eastern bank of the sewer drainage ditch near the western border of the former Tuber Dump (see Photograph No. 4). Cattails were observed about 8 feet north of the location from which Sample No. SW-04 was collected.

Photograph No. 1 Sampling Location: SD-02; SD-02D; SW-02; and SW-02D
Orientation: West Date: 03/23/93
Description: Sampling about 200 feet downgradient of the storm sewer outfall, where duplicate samples were collected; note the small, old, concrete outfall in the distance

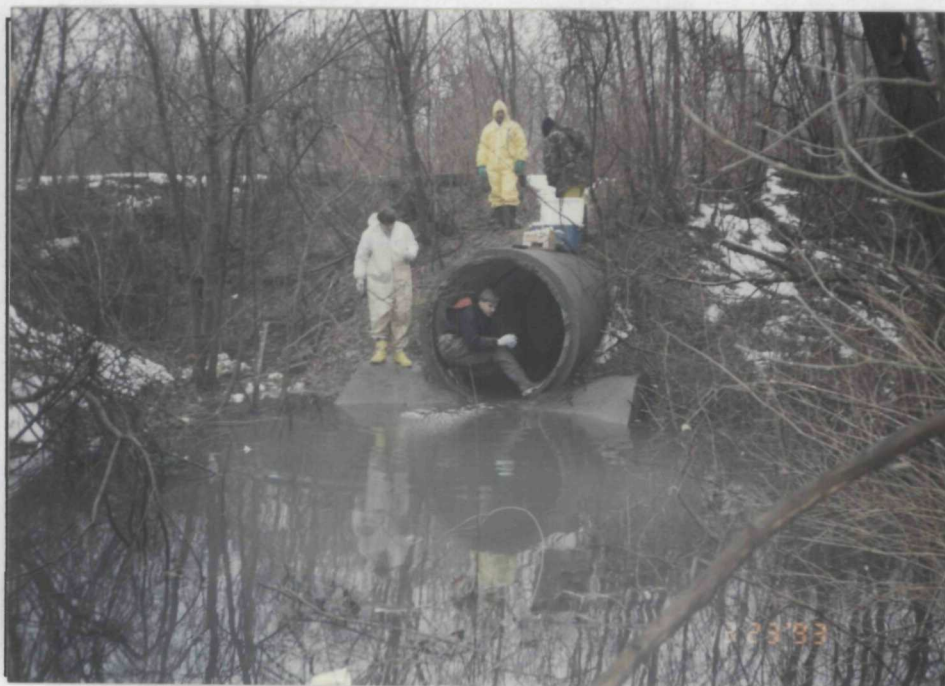
Photograph No. 2
Orientation: West
Description: Sampling within the storm sewer outfall

Sampling Location: SW-01
Date: 03/23/93

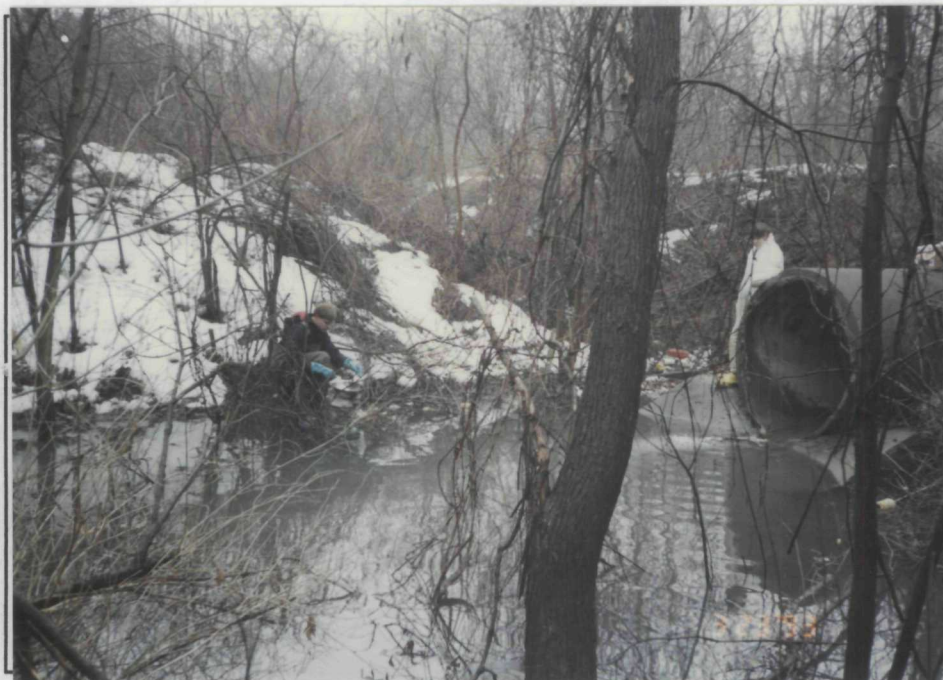
stainless steel scoops, spoons, and bowls. Sample No. SD-01 is a background sample collected along the south bank of the storm sewer ditch about 15 feet southeast of the storm sewer outfall (see Photograph No. 3). This sample was collected to determine concentrations of contaminants attributable to off-site storm water runoff. Sample No. SD-02 was collected along the southern bank of the storm sewer drainage ditch about 200 feet downgradient of where Sample No. SD-01 was collected (see Photograph No. 1). Sample No. SD-02D was collected as a duplicate for Sample No. SD-02. Sample No. SD-03 was collected on the western bank of the northeastern pond. An OEPA on-site investigation states that leachate was observed seeping in the pond in this area. Sample SD-04 was collected from a potential wetland on the eastern bank of the sewer drainage ditch near the western border of the former Tuber Dump (see Photograph No. 4). Cattails were observed about 8 feet north of the Sample No. SD-04 sampling location.

Photograph No. 3
 Orientation: Southwest
 Description: Sampling about 15 feet southeast of the storm sewer outfall

Sampling Location: SD-01
 Date: 03/23/93

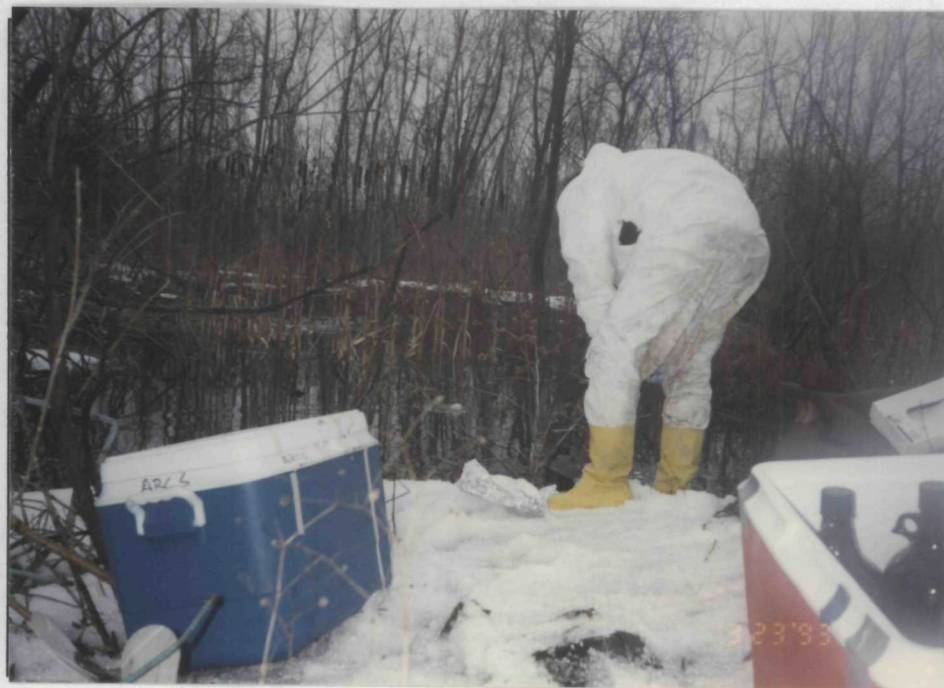
Photograph No. 4
 Orientation: North
 Description: Sampling a wetland; note cattails about 8 feet north of the sampling location; sampling location near northwest portion of the former S.H. Tuber Company (Tuber) Dump

Sampling Location: SD-04 and SW-04
 Date: 03/23/93

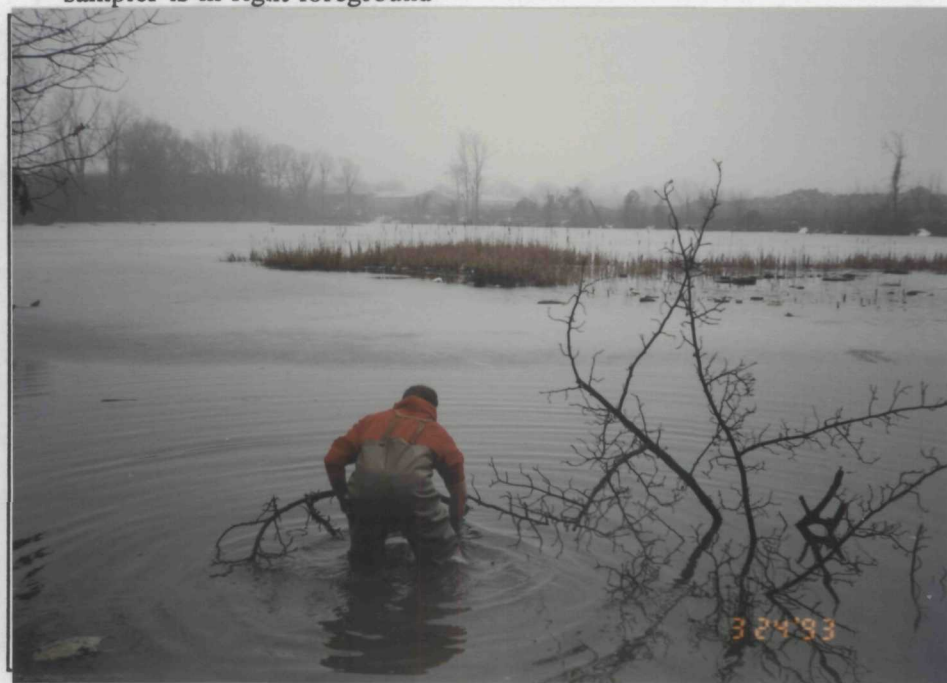
Photograph No. 6

Sample No. SD-06 was collected about 15 feet off shore in the northeast portion of the pond located in the southeast corner of the site (see Photograph No. 6). This pond is delineated as a wetland on the national wetlands inventory map (DOI 1977). A "floating cattail island" was observed in the southern portion of this pond. Sample No. SD-07 was collected from a pond next to the northern border of the former Tuber Dump fill area. Wetland vegetation (cattails) were observed about 20 feet west of this sampling location (see Photograph No. 5). During the reconnaissance, a site representative stated that the Toledo Department of Health and Environment sampled a leachate seep in this area about 1.5 years prior to this investigation. Sampling results for the leachate seep were not available. Sediment east of Sample No. SD-07's sampling location contained many small rocks and other debris such as wood and metal. Sample No. SD-08 was collected from a potential wetland area in the northwest corner of the former Tuber Dump area (see Photograph No. 7). This area is

Sampling Location: SD-06

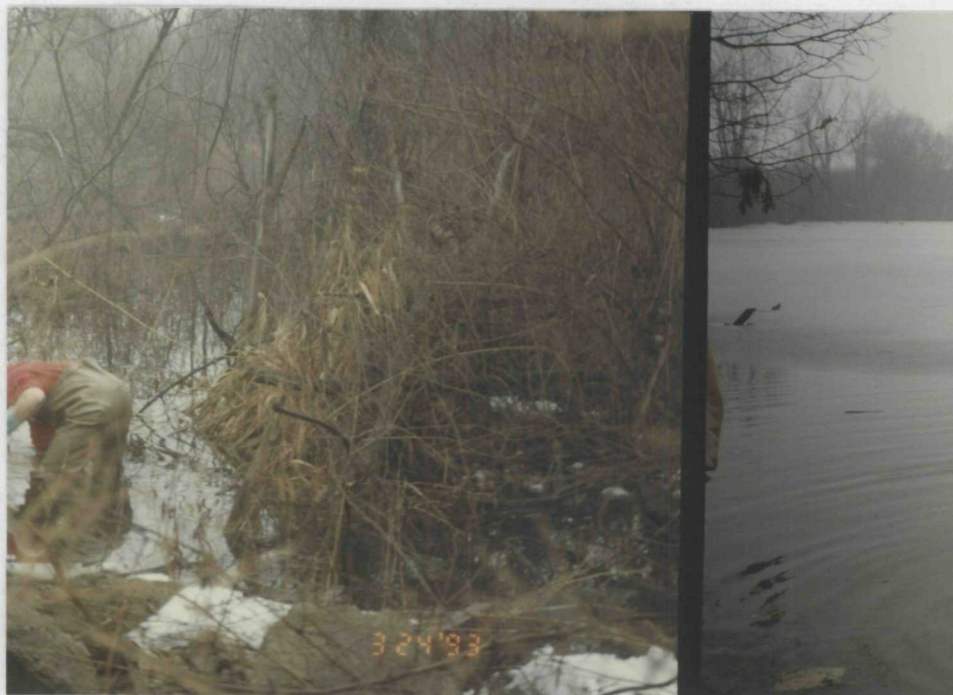
Photograph No. 7

located near the confluence of the storm sewer drainage ditch and the drainage ditch that flows along the eastern border of the site. Large amounts of concrete and metal rubble were observed in this area.

Description: Sampling in a wetland area in the northeast corner of the former Tuber Dump

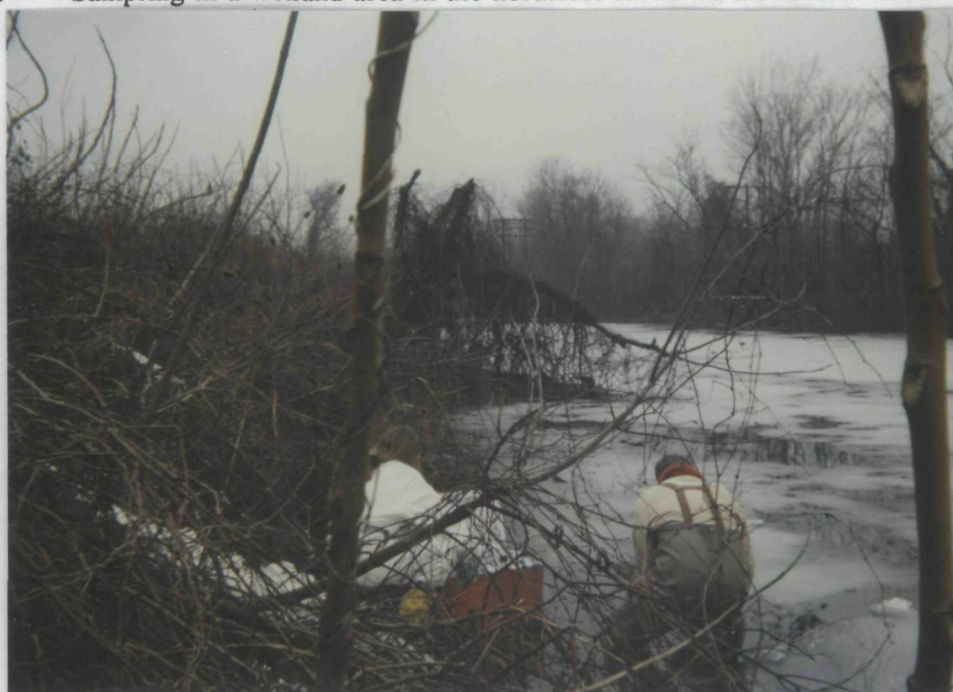
Photograph No. 8

Description: Sampling in the pond located in the northeast portion of the site; note fallen tree in background

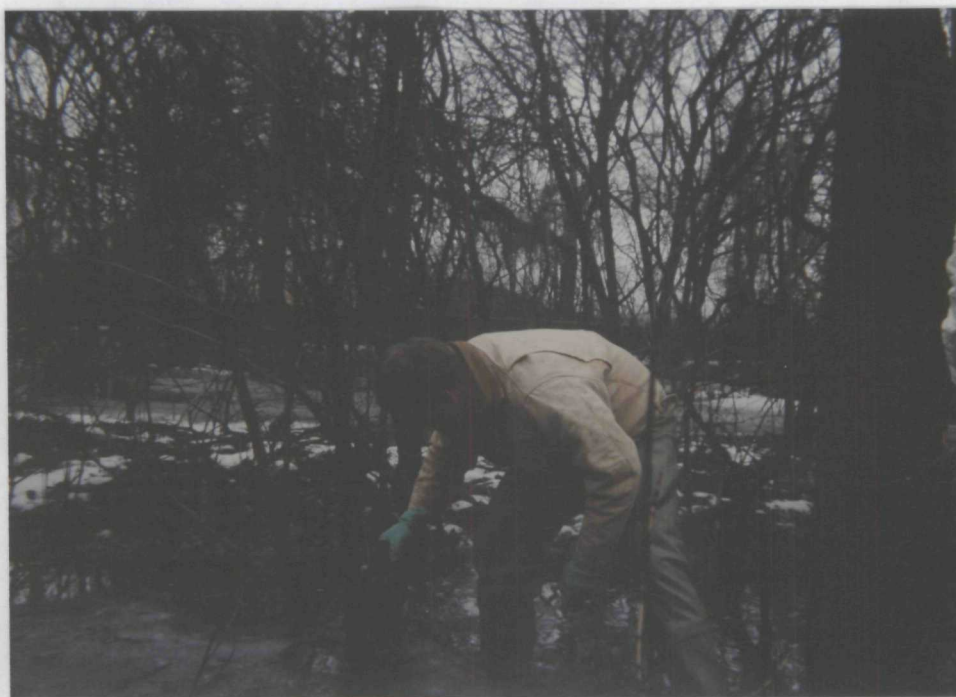
Photograph No. 9

Sampling Location: SW-05

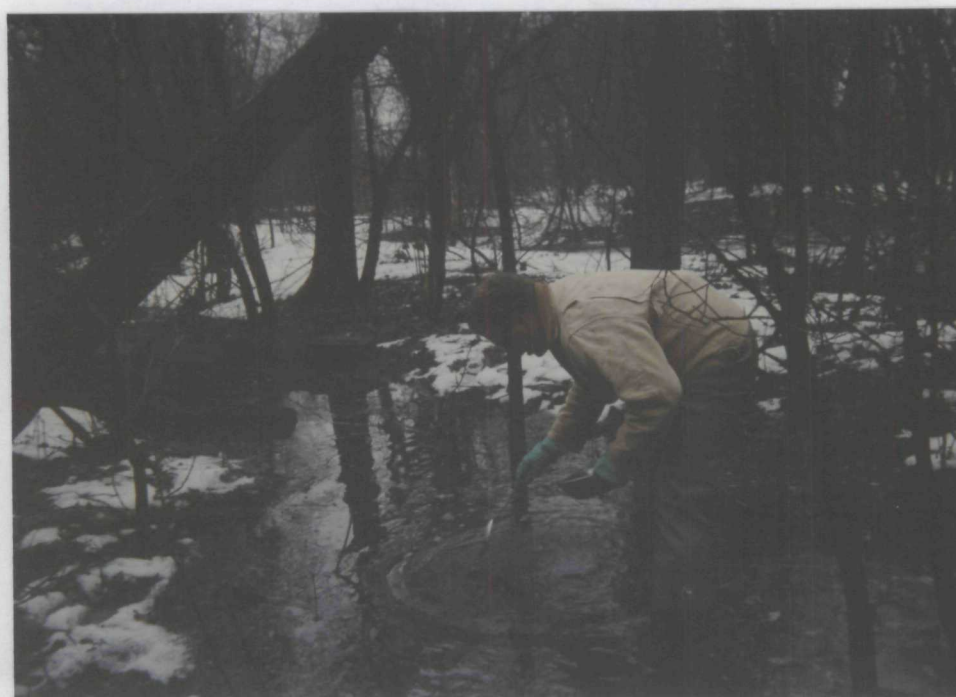
Photograph No. 10

An OEPA on-site investigation states that leachate was observed seeping in the pond in this area. Sample No. SD-05 was collected from the far northwest corner of the site, near the headwaters of the drainage ditch located at the site's western border along Counter Street. The sampling location from which Sample No. SD-05 was collected is about 100 feet south of the north border of the site, immediately east of an old railroad easement, within the drainage ditch about 50 feet south of the location from which Sample No. SW-05 was collected (see Photograph No. 10). Because of its remote location, Sample No. SD-05 was to be a background sample. However, sample results indicate that contaminants from the site have influenced this area.

Sampling Location: SD-05
